# Manhole Inspection Summary

Manhole # S3700\_028MH

Insp Date: **1/29/07 8:55 AM**

**Location** Address: **415 23RD ST**

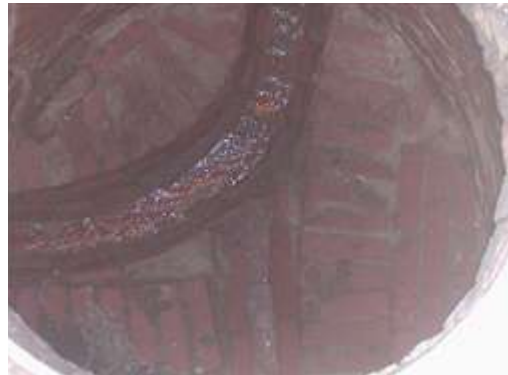
Top View

Corroded steps. Evidence of surcharge - Bench debris.

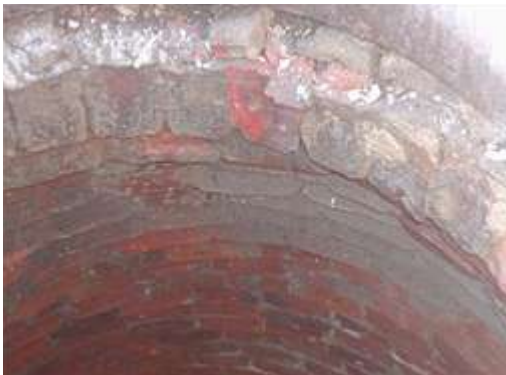
Defect

Frame leaks. Adjustment deterioration, loose brick and infiltration.

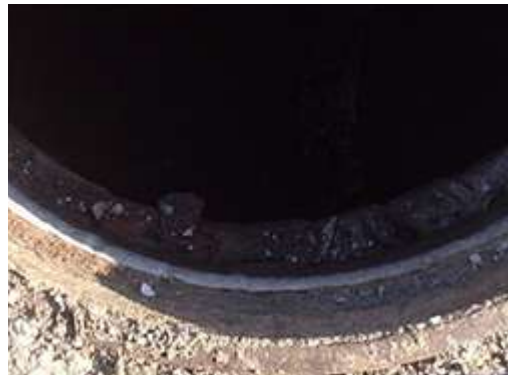
Defect

Frame leaks. Frame offset.

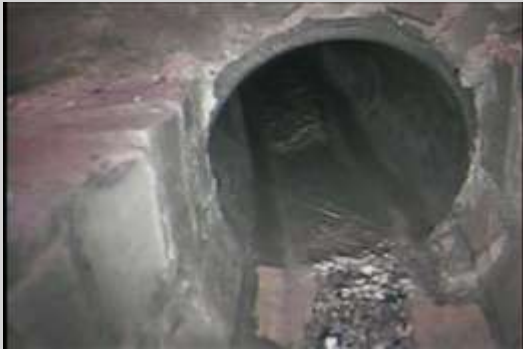
### 8 in. Circular Gravity Sewer Pipe Out @ 12 O'Clock

Infiltration: **Evidence** Pipe Seal Cond: **Unknown**

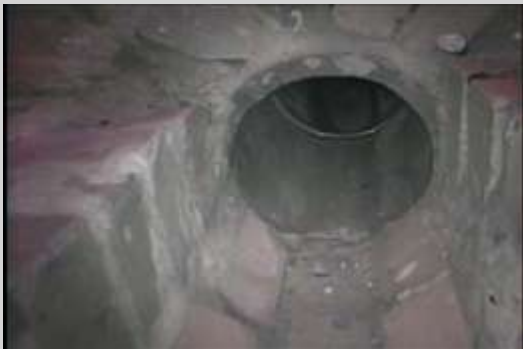
### 6 in. Circular Gravity Sewer Pipe In @ 6 O'Clock

Infiltration: **Evidence** Pipe Seal Cond: **Unknown**

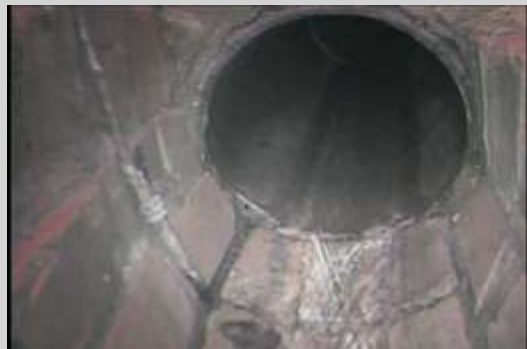
Pipe In @ 9 O'Clock

Infiltration: **Evidence**
